# Human factors and bridge failure

**Sean Brady** stresses the importance of managing “human factors” to reduce human error within bridge projects, citing international examples from which lessons can be learned.

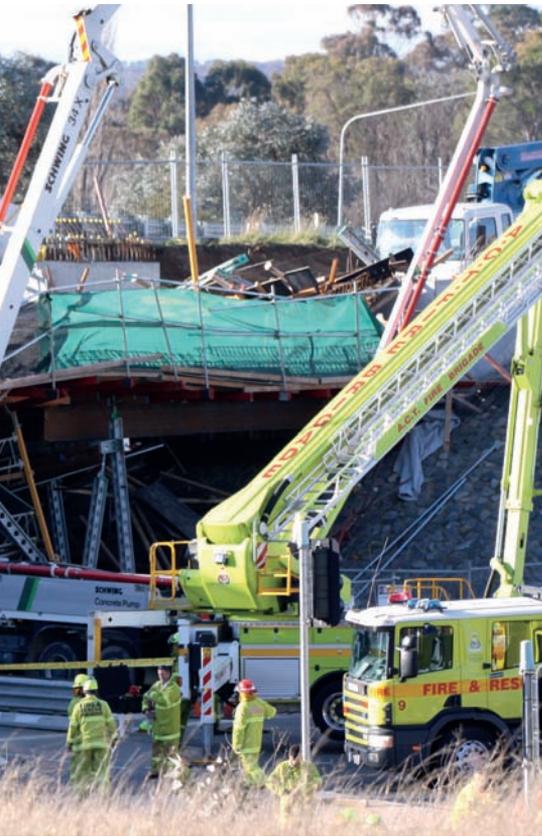
While the vast majority of bridge structures perform satisfactorily throughout their lifetime, bridge failures still continue to occur throughout the world, with the collapse of temporary formwork during a bridge’s construction in Canberra, Australia, being a recent example (Figure 1). Fortunately, the failure resulted in no fatalities, but it was the third such temporary works collapse in recent years - a cable-stayed pedestrian bridge failed during construction in the US in 2008, and a 20m long section of formwork collapsed during a concrete pour for a partially cable stayed bridge in the Pyrenees in 2009. In addition to these construction failures, there have also been a number of catastrophic bridge collapses in service:

**Figure 1**  
Bridge over Barton Highway, Canberra, Australia. 15 workers were injured

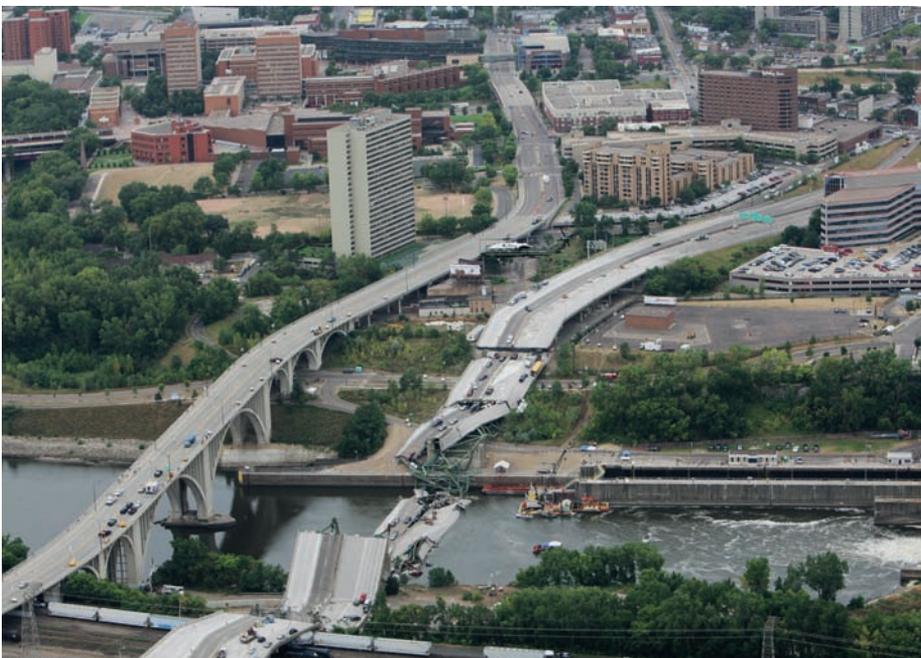
Just after 6pm on Wednesday 1 August 2007, the main span of the I-35W highway bridge in Minneapolis collapsed into the Mississippi River, resulting in 13 fatalities (Figure 2). The subsequent National Transportation Safety Board (NTSB) investigation identified under-sized gusset plates, in combination with increases in dead and live load on the bridge, as the cause of collapse.

While the under-sized gusset plates, which were the result of a design error, initiated the bridge’s collapse, it was human factors that permitted this error to go unnoticed for 40 years, despite numerous opportunities for its identification. Among the human factors identified by the NTSB investigation were:

**Figure 2**  
Collapse of I-35W Highway Bridge into Mississippi River, USA. 13 people were killed

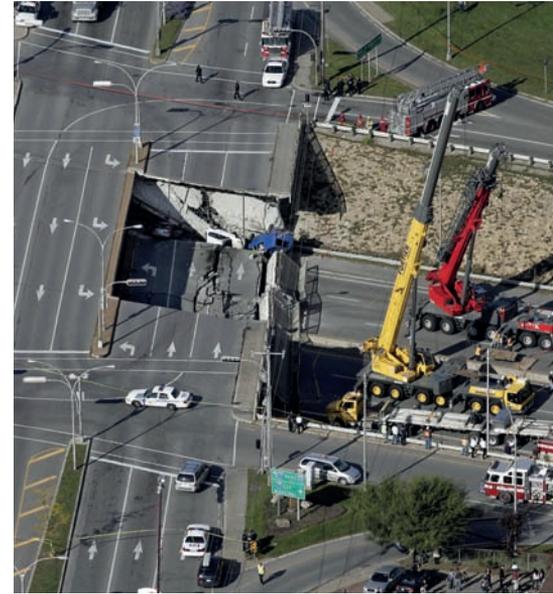
**Figure 3**  
Five fatalities as a result of shear failure of a cantilevered slab through concrete deterioration: de la Concorde Overpass, Montreal, Canada

A year prior to the I-35W failure, the collapse of an overpass in Montreal, Canada, resulted in five fatalities (Figure 3). The overpass consisted of a drop-in span comprised of prestressed concrete box girders, which were supported by cantilevered slabs, via halving joints. The Commission of Inquiry into the collapse concluded that the failure of the overpass was a result of a shear failure of a cantilevered slab. The Commission concluded that the shear failure was caused by concrete deterioration, with a number of other contributing factors playing a role in the collapse, such as a lack of shear reinforcement in the cantilevered slab, a lack of watertightness in the slab, and damage caused in previous rectification works.

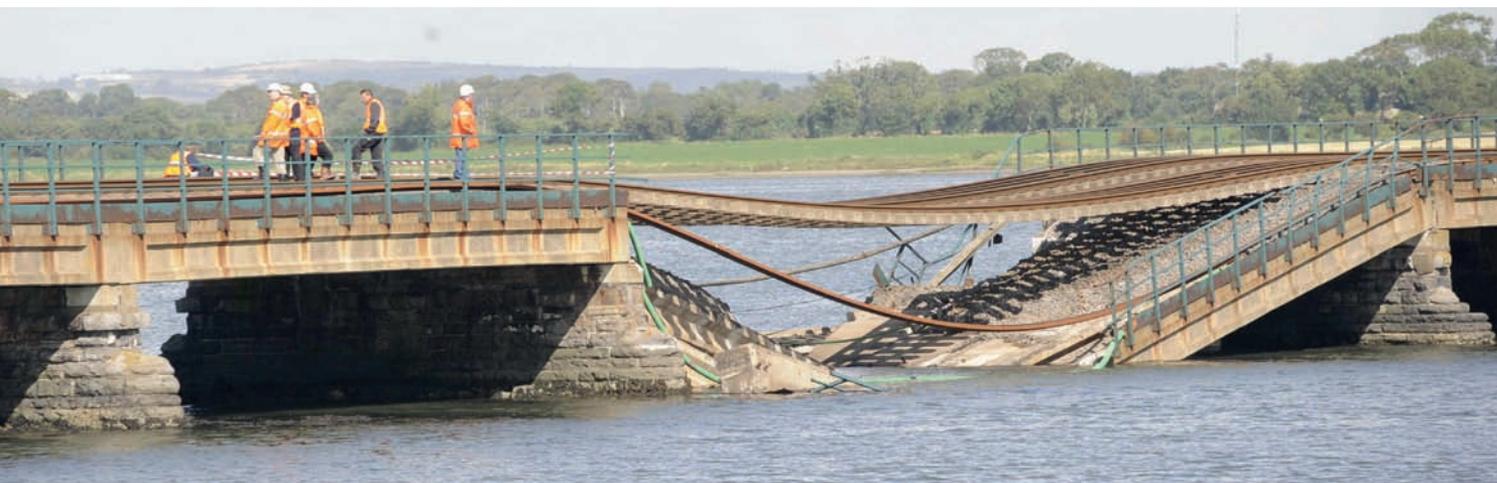
In 2009, just outside Dublin, Ireland, Pier 4 of the Malahide Viaduct collapsed into the Broadmeadow Estuary, resulting in the partial failure of two spans. An investigation by the Railway Accident Investigation Unit (RAIU) identified the cause of the failure as scour action undermining the rock weir that surrounded and supported Pier 4, leading to the pier’s failure.

**Figure 3**  
Sudden collapse of Malahide Viaduct’s Pier 4, Ireland
