# The Quebec Bridge collapse: a preventable failure (part 1)

**In the first of a two-part article, Sean Brady takes readers through the chain of events that led to the collapse during construction, with 75 deaths, of the Quebec Bridge.**

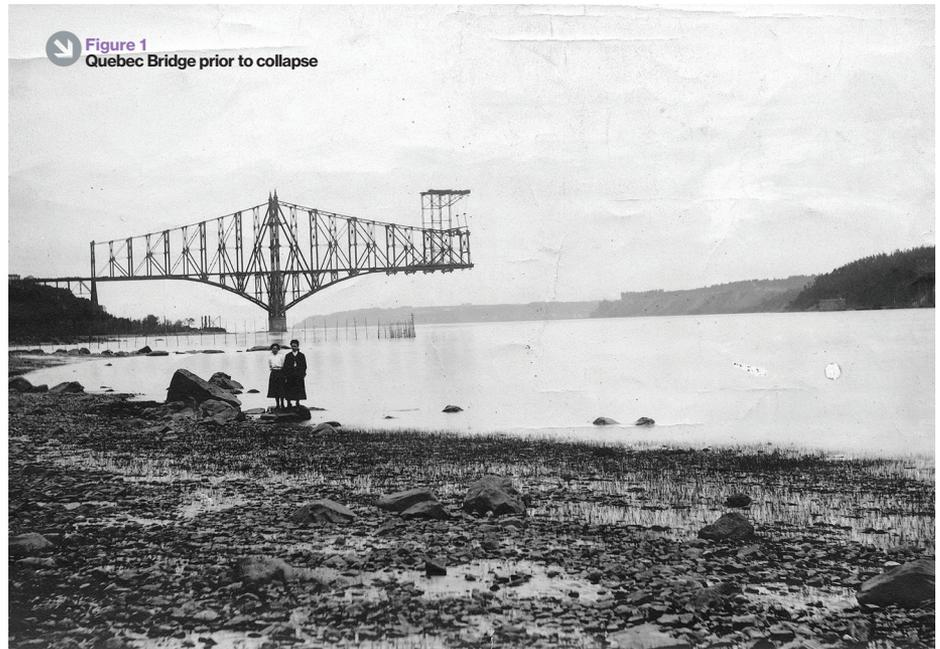
However, evidence that the design may not have been adequate began to present itself in June 1907, 23 months into construction of the superstructure. McLure identified that a number of the bridge's compression members had mid-point deflections – they were bowing. This bowing was most pronounced in the compression members on either side of the bridge piers (known as A8L and A9L). These members carried some of the largest compression loads in the bridge. In early June, it was found that member A9L had a bow of 1–2mm, but later that month these deflections had grown to 19mm. McLure notified both Cooper and the Phoenix Design Company's chief engineer.

But by late August 1907, there was no doubt that an issue existed. In the space of two weeks the bow in the A9L member had increased from 19mm to 57mm<sup>1</sup>. With the

southern cantilever arm suspended 223m over the St Lawrence River (Figure 1), the scene was set for catastrophe.

The decision came too late. At 5:30pm that evening, while the meeting in Phoenixville was wrapping up, the critical A9L member buckled, initiating the progressive collapse of the 17 000t southern arm of the bridge into the St Lawrence River. The bridge took 15 seconds to collapse and was heard over 10km away in Quebec City. Only 11 of the 86 workers on the bridge at the time would survive, with a number of bodies never being recovered.
