# Interstate 90 Connector Tunnel ceiling collapse

**Sean Brady highlights potential similarities between the recent Sasago road tunnel collapse in Japan and the catastrophic failure of part of Boston's I-90 Connector Tunnel in 2006.**

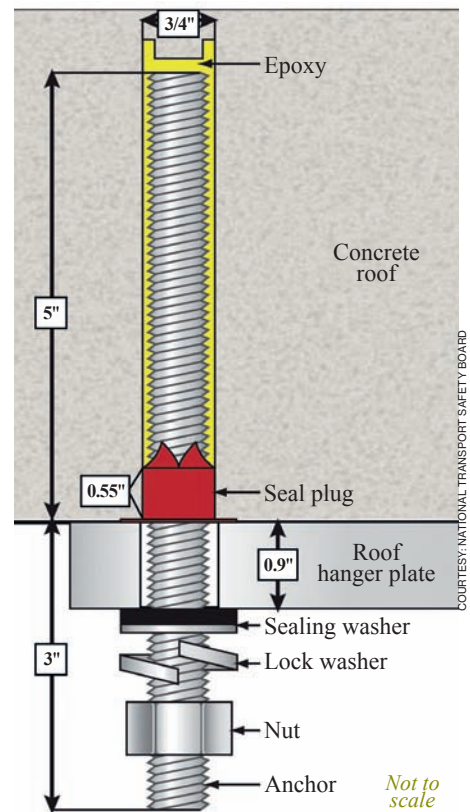
with the failed section being installed in November 1999. The suspended ceiling consisted of concrete ceiling panels and associated steel support framework, and it was suspended from the tunnel roof by stainless steel anchors held in place with epoxy adhesive. Notably, the specification produced by the tunnel ceiling designer, Gannett Fleming, did not contain criteria with respect to the long term performance of the anchoring system (Figure 1).

**Figure 1**  
Typical adhesive anchor and roof hanger plate assembly

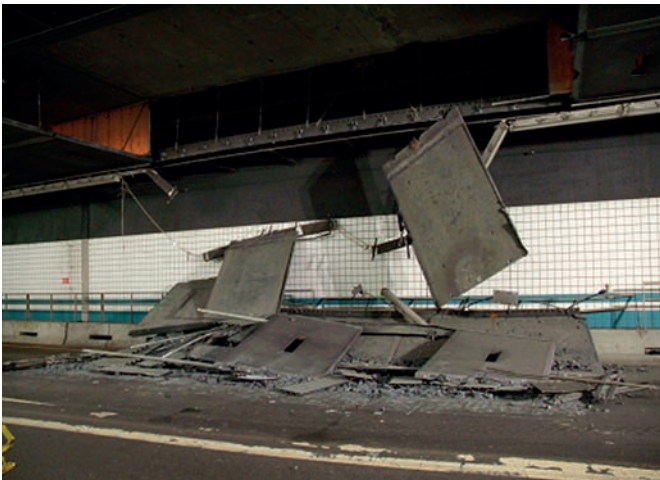
The incident occurred at approximately 23:00h on Monday the 10 July, 2006, more than six years after the D Street portal opened to traffic. A car travelling eastbound in the tunnel was struck by about 24t of falling ceiling panels and steel framework that detached from the tunnel roof. The right hand side of the car was crushed, with the driver suffering minor injuries and the passenger, the driver's wife, being fatally injured (Figure 2).

An investigation into the collapse was commenced by the National Transportation Safety Board (NTSB), who established that all 20 epoxied anchors that connected the ceiling panel's M1 support beam had pulled free from the tunnel roof. Further, an examination of the hardened epoxy, which was still attached to the failed anchors, suggested that a number of the anchors had been pulled some distance out of the tunnel roof (displaced) prior to the incident occurring.

← **Figure 2**  
Approximately 24t of concrete ceiling panels crush a vehicle resulting in a fatality

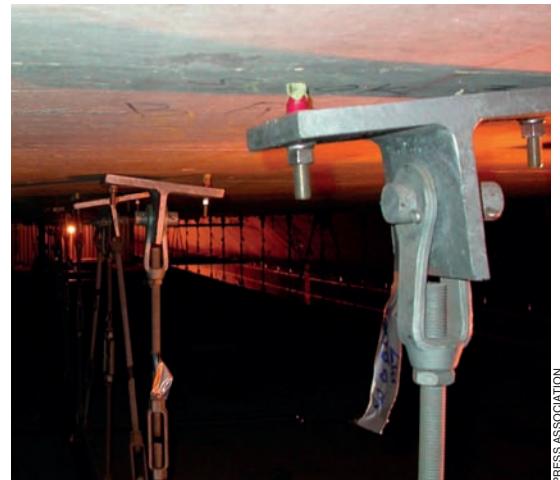
Following the collapse, an inspection of the remaining 634 anchors in the D Street tunnel found that 161 of them had measurable displacement consistent with them being gradually pulled out by the weight of the concrete ceiling panels (Figure 3). Given this evidence, the NTSB concluded "by July 2006, a significant portion of the adhesive anchors used to support the D Street portal ceilings had displaced to the extent that, without corrective action, several of the ceiling modules in the three portal tunnels were at imminent risk of failure and collapse"<sup>1</sup>.

→ **Figure 3**  
Displaced hanger plates

had similar performance under short term loading, they were dramatically different under long term loading situations, with Fast Set epoxy exhibiting significant displacement when subject to constant loading. Based on these findings, the NTSB concluded that “the source of the anchor displacement that was found in the D Street portal tunnels and that precipitated the ceiling collapse was the poor creep resistance of the Power-Fast Fast Set epoxy used to install the anchors”<sup>1</sup>.
