Lessons from the Malahide

Sean Brady investigates the contribution of 'corporate memory loss' to the failure of a railway bridge near Dublin, Ireland.

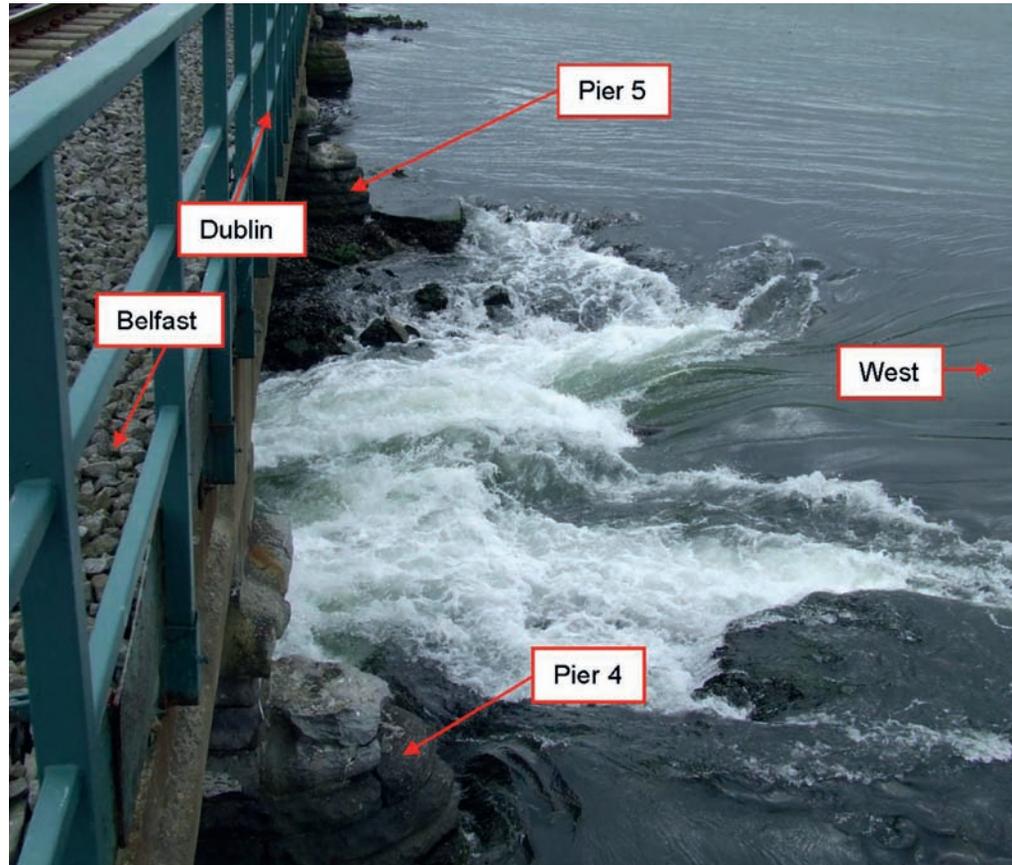
Unsurprisingly, the subsequent investigation, conducted by the Railway Accident Investigation Unit (RAIU), concluded that scour action had undermined the foundations of Pier 4, leading to the collapse. While the cause of the failure was technical, the non-technical lessons from this collapse serve as a reminder of the importance of knowledge and information for organisations involved in the management of structural assets.

← **Figure 1**
Evidence of erosion around Pier 4 three days prior to collapse

Finally, as with all significant failures, opportunities to identify the potential for failure were missed. For example, four days prior to the collapse, on the 17 August, a group leader of the Malahide Sea Scouts, who was a regular canoeist on the estuary, noticed that some of the stones around the base of Pier 4 had been washed away. He informed Iarnród Éireann, and an assistant engineer investigated. The engineer carried out the inspection on the viaduct the following day and identified that some of the masonry pier's stonework was missing or cracked, assuming this was the issue reported by the Scout's leader, and reported that he found no major structural defects.

However, during the inspection the engineer took a photograph (Figure 1) which clearly indicates the presence of some serious erosion around Pier 4. Not only does this incident highlight a missed opportunity to identify the potential for failure, but it also highlights the poor training the inspectors received in the identification of scour related issues.
