Pedestrian Bridge Collapse Over SW 8th Street, Miami, Florida

March 15, 2018

NTSB | National
Transportation
Safety Board

Illustrated Digest

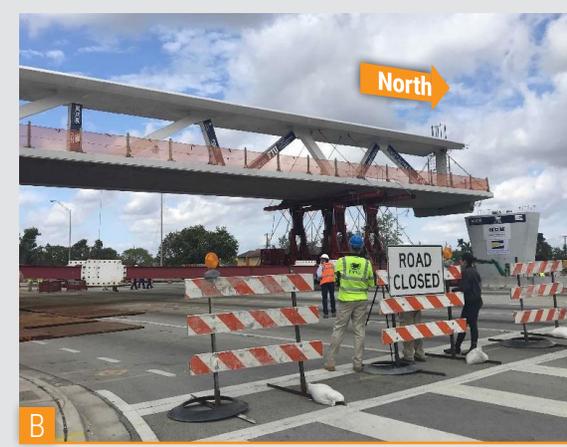
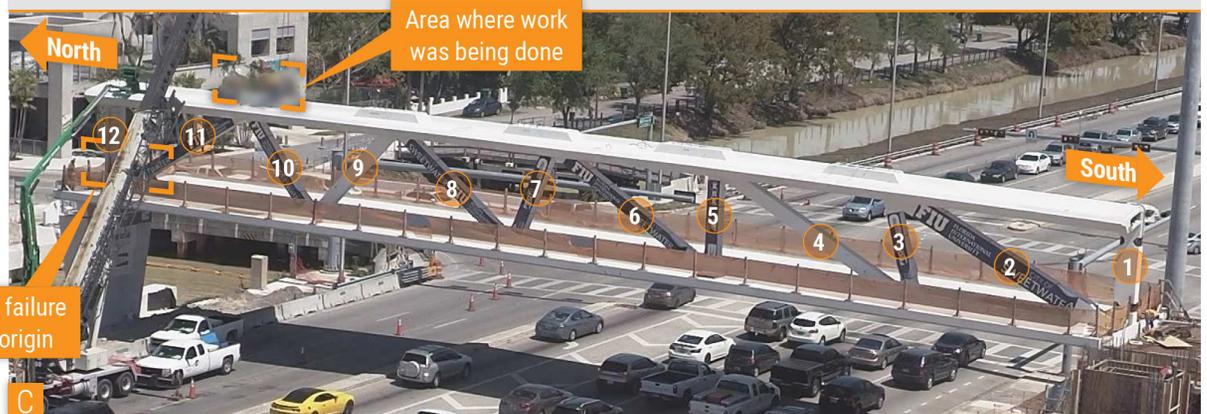
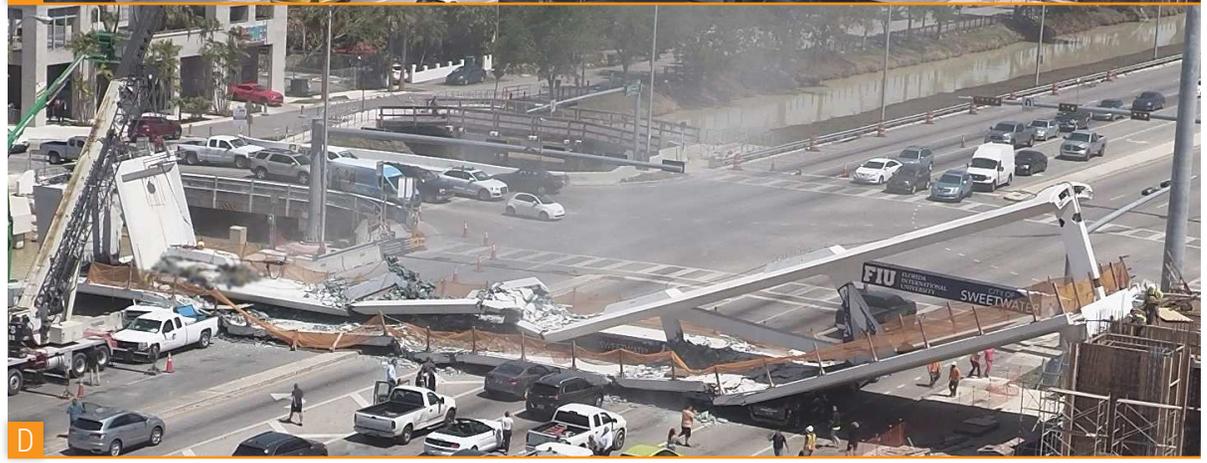
The bridge was built in stages (A) in a casting yard adjacent to SW 8th Street. (See The ABCs of ABC, page 9). On **March 10**, it was moved on self-propelled modular transporters (SPMTs) onto its support piers (B). On **March 15**, an FIU parking garage camera captured the bridge precollapse (C) and postcollapse (D). (See From cracks to collapse, page 9).

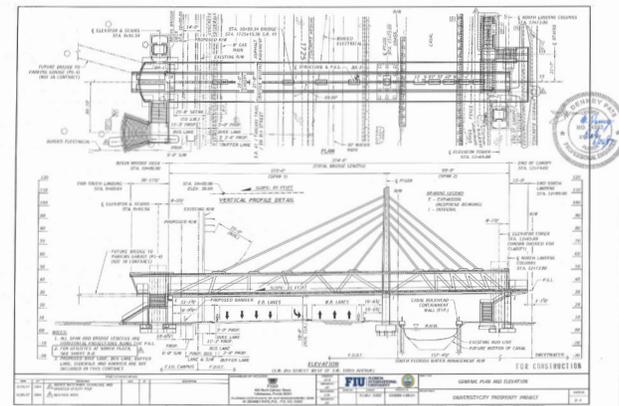
A “General Plan and Elevation” drawing from the set of “released for construction” plans showing the proposed structure, bearing the seal and signature of the EOR.

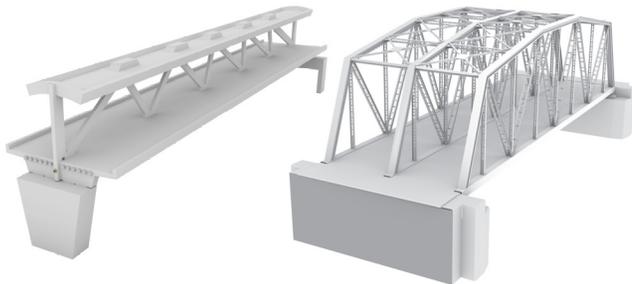
Above: **Nonredundant** FIU pedestrian bridge main span (left) and exemplar **redundant** steel truss bridge (right).

A non-load-path-redundant structure has fewer load paths than necessary to maintain stability following the failure of one or more critical components, likely resulting in collapse of the structure. With truss members in a single plane along its centerline, this bridge was not a load-path-redundant structure.

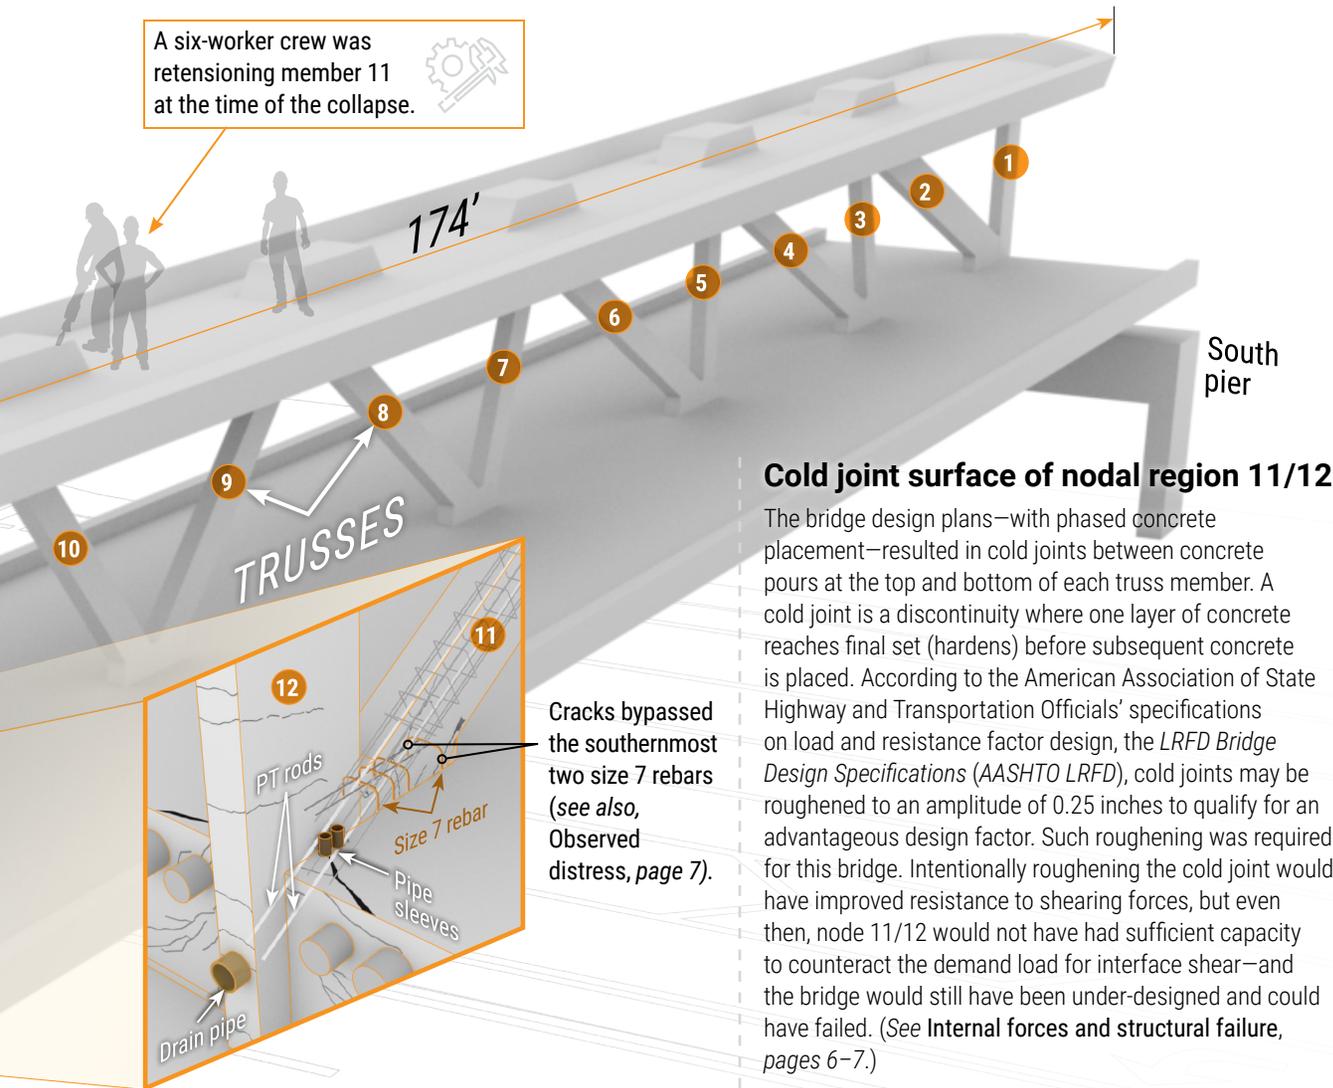
Cold joint surface of nodal region 11/12

The bridge design plans—with phased concrete placement—resulted in cold joints between concrete pours at the top and bottom of each truss member. A cold joint is a discontinuity where one layer of concrete reaches final set (hardens) before subsequent concrete is placed. According to the American Association of State Highway and Transportation Officials' specifications on load and resistance factor design, the *LRFD Bridge Design Specifications (AASHTO LRFD)*, cold joints may be roughened to an amplitude of 0.25 inches to qualify for an advantageous design factor. Such roughening was required for this bridge. Intentionally roughening the cold joint would have improved resistance to shearing forces, but even then, node 11/12 would not have had sufficient capacity to counteract the demand load for interface shear—and the bridge would still have been under-designed and could have failed. (See **Internal forces and structural failure**, pages 6–7.)

Cracks bypassed the southernmost two size 7 rebars (see also, **Observed distress**, page 7).

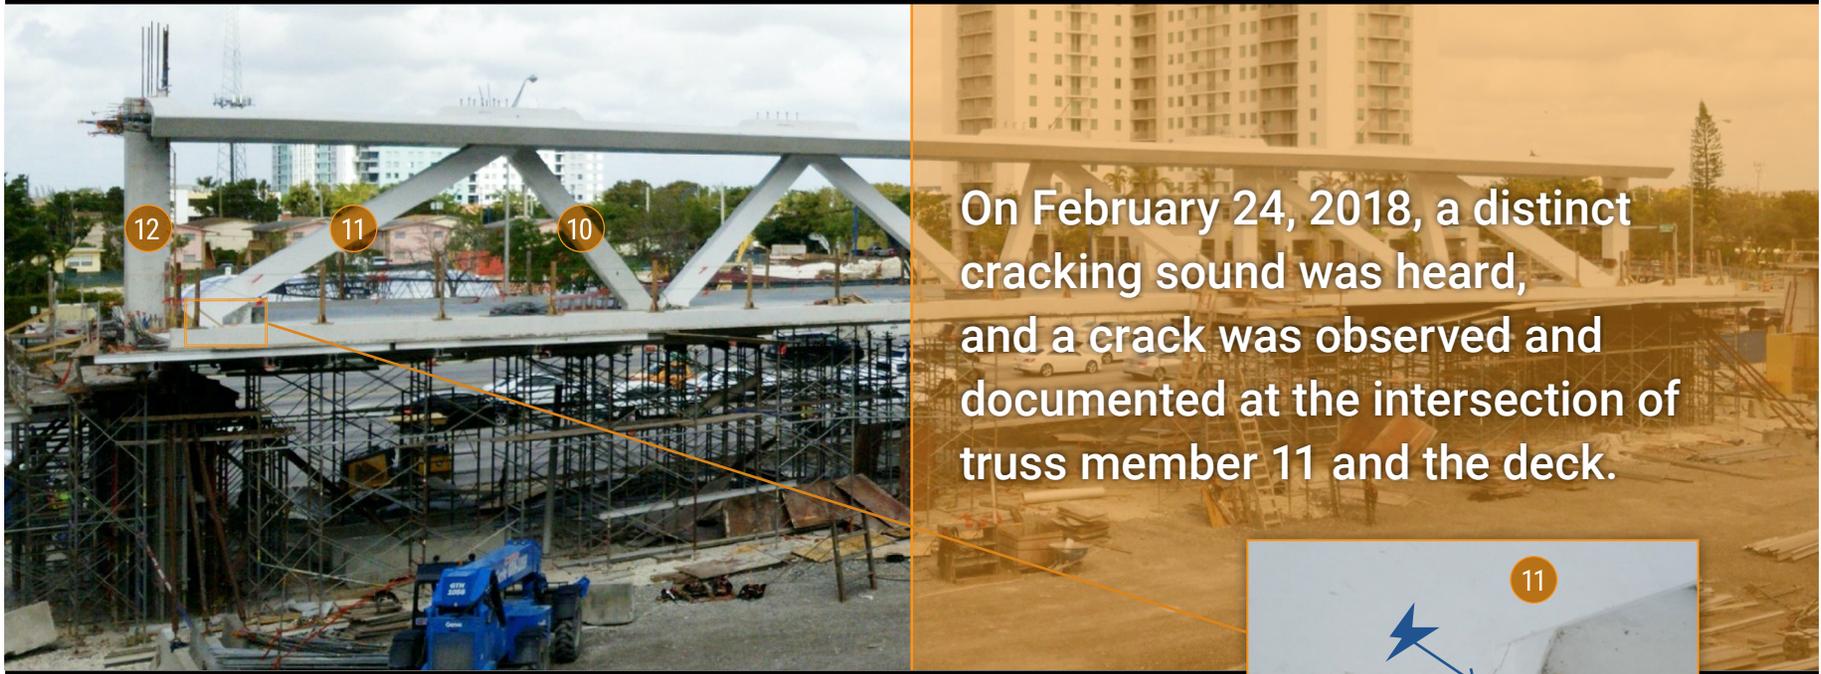
On February 24, 2018, a distinct cracking sound was heard, and a crack was observed and documented at the intersection of truss member 11 and the deck.

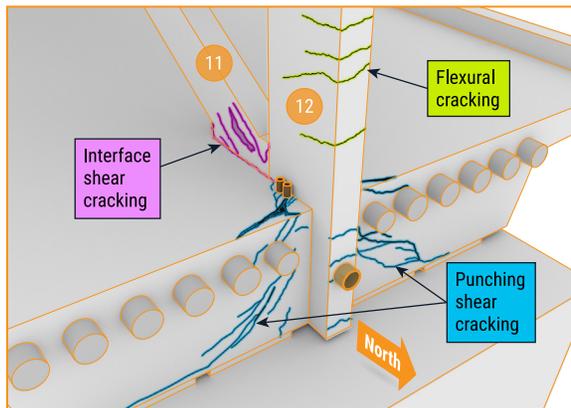
The five hollow pipes within the 11/12 nodal region and diaphragm acted as voids within the concrete mass, subjecting the surrounding concrete to higher stress concentrations and the unanticipated redirection of the load path.

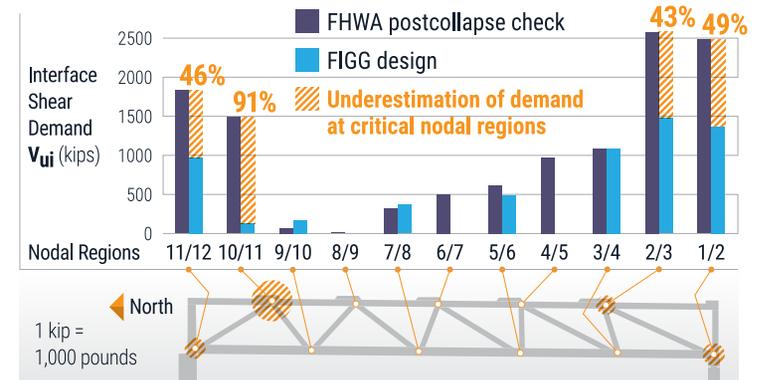
The FHWA's postcollapse analysis determined that the FIGG calculations underestimated the interface shear demand at node 11/12 by 46 percent; the actual demand was nearly twice what FIGG calculated. (The demand at other nodes was also miscalculated; for node 10/11 demand was nearly 10 times what FIGG calculated). See figure at right.

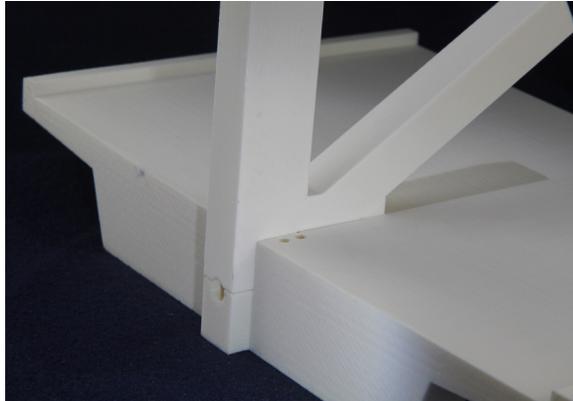
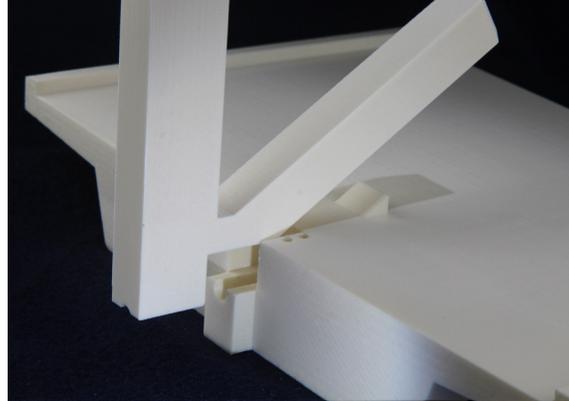
The FHWA provided the NTSB with a 3D printed model during the NTSB's investigation. The 3D printed model of node 11/12 illustrates the movement of members 11 and 12 to the north (with respect to the deck) that initiated the collapse of the pedestrian bridge.
