## The roles of technical engineering experts in construction disputes

### The I-35W Bridge

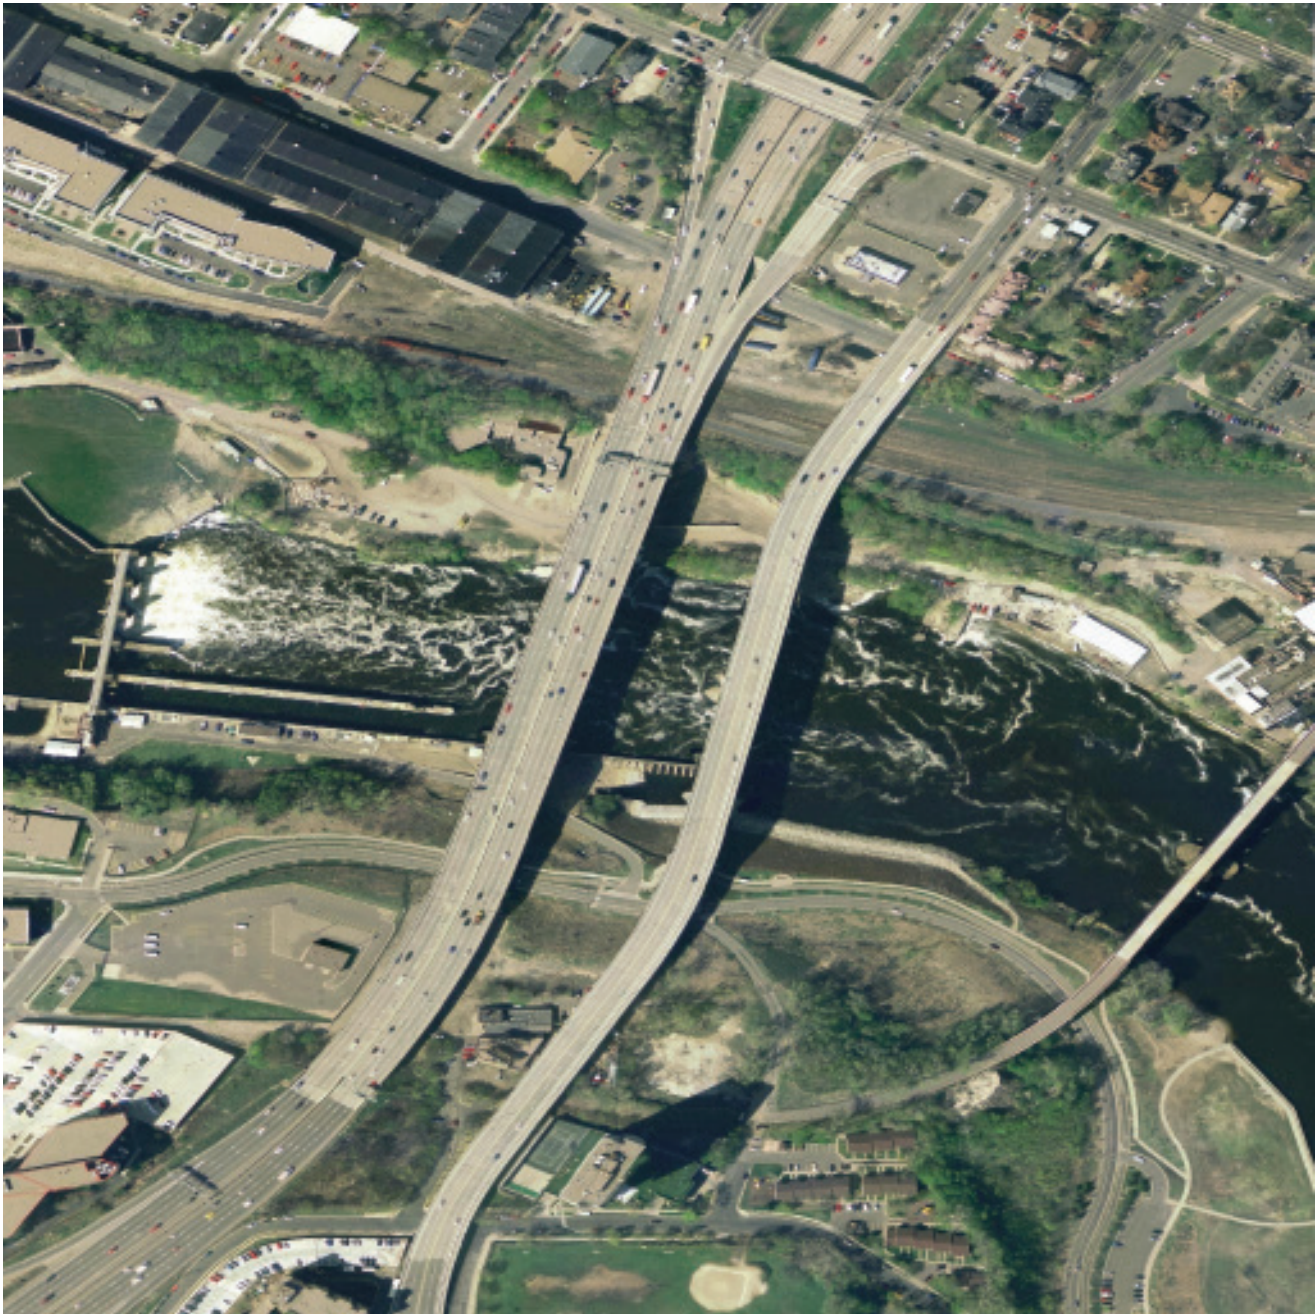
Aerial view of the I-35W Mississippi River Bridge and the surrounding area. The bridge collapsed in August 2007. Just to its right is the older 10th Avenue Bridge. Credit: U.S. Geological Survey
