# Human factors and bridge failure

**Sean Brady** stresses the importance of managing “human factors” to reduce human error within bridge projects, citing international examples from which lessons can be learned.

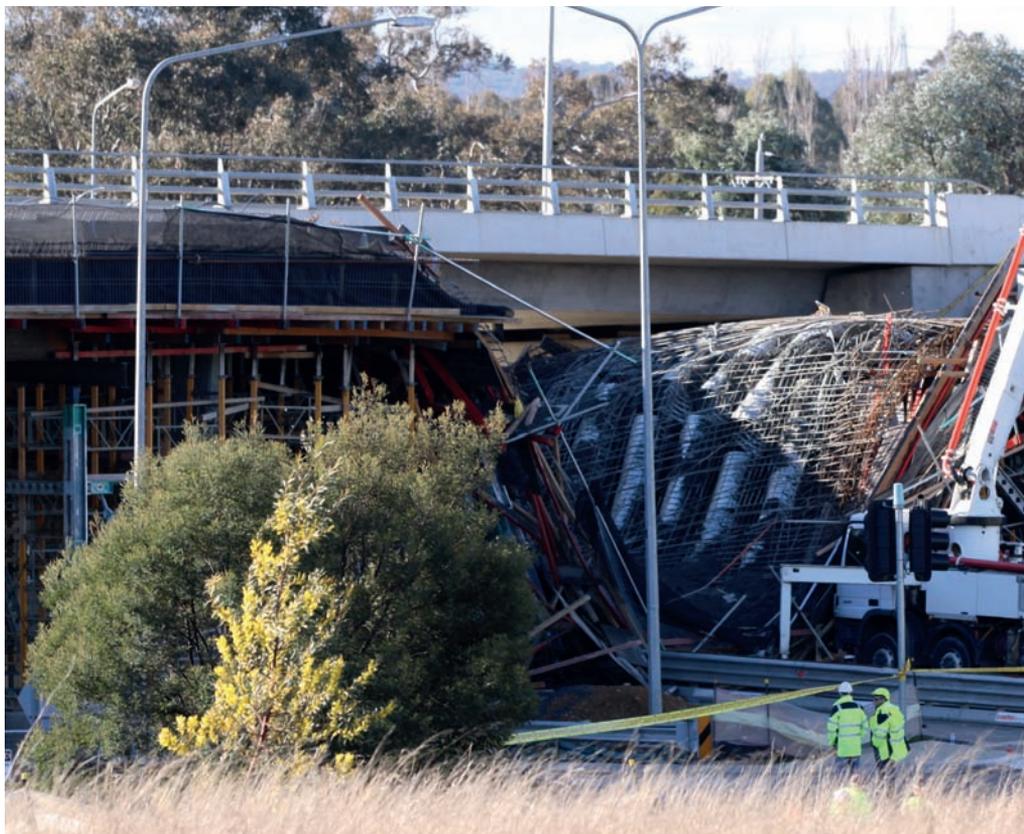
While the vast majority of bridge structures perform satisfactorily throughout their lifetime, bridge failures still continue to occur throughout the world, with the collapse of temporary formwork during a bridge’s construction in Canberra, Australia, being a recent example (Figure 1). Fortunately, the failure resulted in no fatalities, but it was the third such temporary works collapse in recent years - a cable-stayed pedestrian bridge failed during construction in the US in 2008, and a 20m long section of formwork collapsed during a concrete pour for a partially cable stayed bridge in the Pyrenees in 2009. In addition to these construction failures, there have also been a number of catastrophic bridge collapses in service:

**Figure 1**  
Bridge over Barton Highway, Canberra, Australia. 15 workers were injured
