Pedestrian Bridge Collapse Over SW 8th Street, Miami, Florida

March 15, 2018

NTSB | National
Transportation
Safety Board

Illustrated Digest

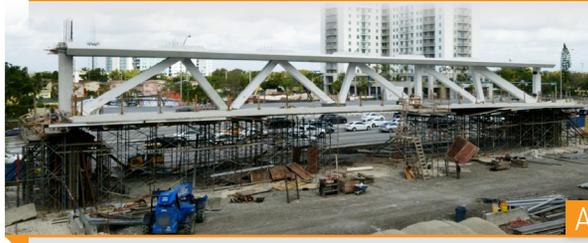
The bridge was built in stages (A) in a casting yard adjacent to SW 8th Street. (See The ABCs of ABC, page 9). On **March 10**, it was moved on self-propelled modular transporters (SPMTs) onto its support piers (B). On **March 15**, an FIU parking garage camera captured the bridge precollapse (C) and postcollapse (D). (See From cracks to collapse, page 9).

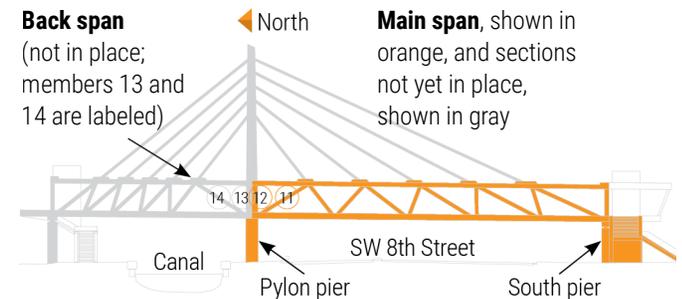
The back span that was never built

Although the design should have allowed member 11 to resist the shear forces on its own, additional resistance could have been provided later in the construction sequence. Once the back span had been built, the horizontal force component from diagonal member 14 would have been pushing south toward vertical members 13 and 12, helping counteract or resist the northward force in truss member 11 at the 11/12 nodal region.

Because the back span had not yet been constructed, however, **the northward shear force caused by the structure's self-weight and the retensioning of member 11 was able to push through the bottom of member 12 and the diaphragm**, causing the bridge to collapse.

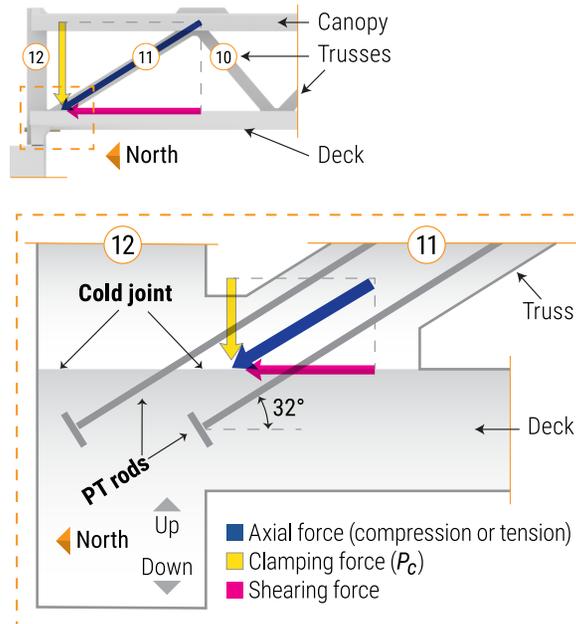
In this bridge, the vertical, or downward, component force provided a clamping effect across the cold joint between member 11 and the deck. The horizontal, or northward, force provided a shear force at the cold joint, pushing the bottom of member 11 toward the north. Unique to node 11/12:

- PT rods generated vertical clamping force and horizontal shear force
- 32-degree angle produced 60 percent larger horizontal shear than vertical clamping force

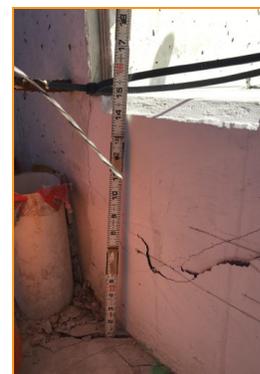
March 13 at 11:18 a.m.

Selected communications and photographs related to observed cracks in member 11/12 nodal region.
